In-Field Performance of Geosynthetics
Used To Reinforce Roadway Base Layers;
Phase I: Instrumentation Selection and Verification

Final Report

Prepared by
Dr. Steven W. Perkins
Assistant Professor
&
Joseph A. Lapeyre
Graduate Research Assistant

1. Report No. FHWA/MT-96/8126		2. Government Accession No.	3. Recipient's Catalog No.
4. Title and Subtitle In-Field Performance of Geosynthetics Used to Reinforce Roadway Base Layers; Phase I: Instrumentation Selection and Verification		5. Report Date September 30, 1996

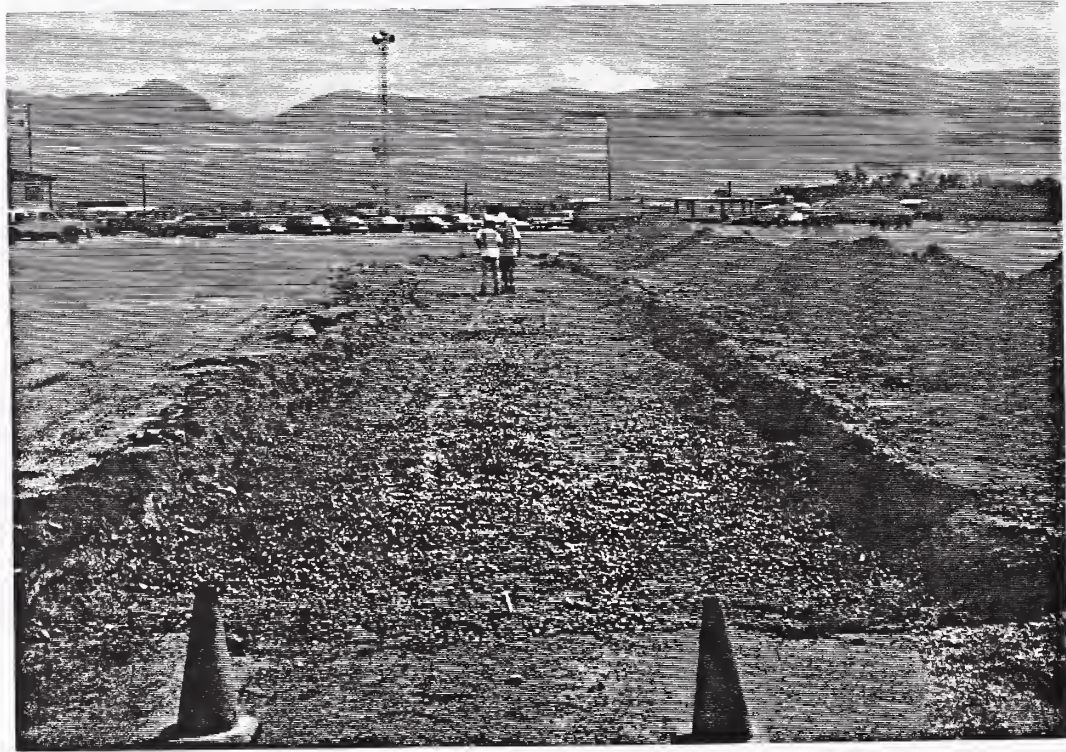
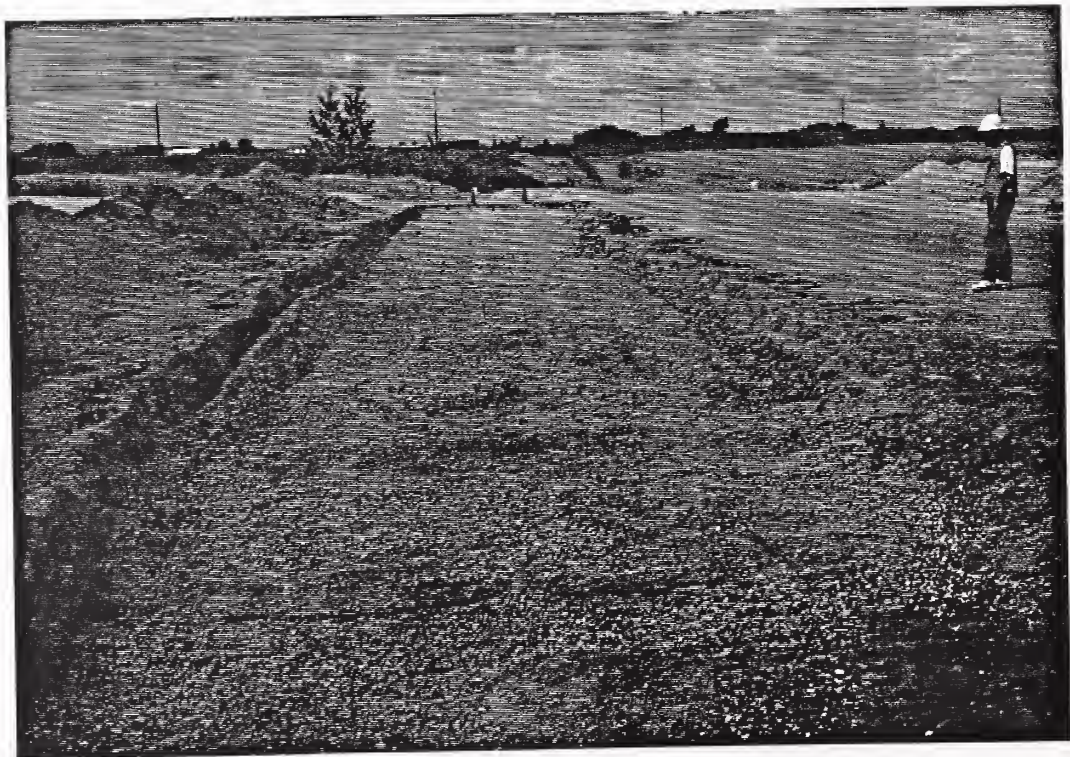
Figure A3.1: Excavated Test Section Prior to Placement of Geosynthetics, a) looking Northeast, b) looking Southwest.

The test section was constructed by excavating the existing asphalt and subgrade along a straight section measuring 42.7 m (140 ft) in length by 4.6 m (15 ft) in width. The existing asphalt was 10 to 40 mm (0.4-1.6 in) in thickness. The existing subgrade consisted of a dry to moist, silty, sandy gravel with cobbles. The subgrade appeared to be at a relative density of 75-85 %. The excavation extended to approximately 267 mm (10.5 in) below the top of the existing asphalt grade. Approximately 100 mm (4 in) of the subgrade was scarified and recompacted with a vibratory steel drum roller. A thin layer of base course material was placed and spread to level the bottom of the excavation. This layer was not compacted and ranged in thickness from 10 to 50 mm (0.4-2 in). Views of the test section at the completion of this stage are shown in Figure A3.1. Figure A3.1a is a view looking to the Northeast. The weigh scale office can be seen in the extreme upper left hand side of the photograph. The scale is on the east side of the building. Figure A3.1b shows a view looking to the Southwest. The entrance to the gravel pit is immediately to the right (west) of the end of the test section. When completed, trucks enter the pit along the existing travel way to the west of the test section and return by entering onto the test section when coming out of the pit and traveling towards the weigh scale. In this way, the test section only sees loaded trucks whose weights are recorded at the scales.

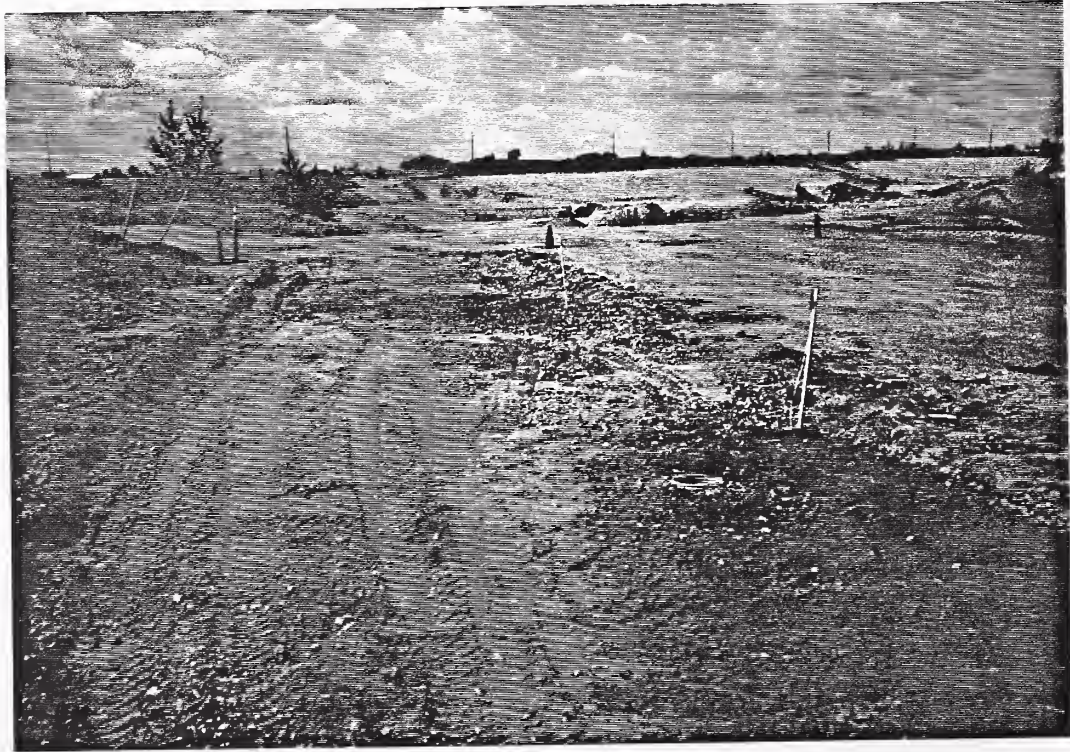
Figure A3.4: Test Section After Placement of Base and Prior to Compaction

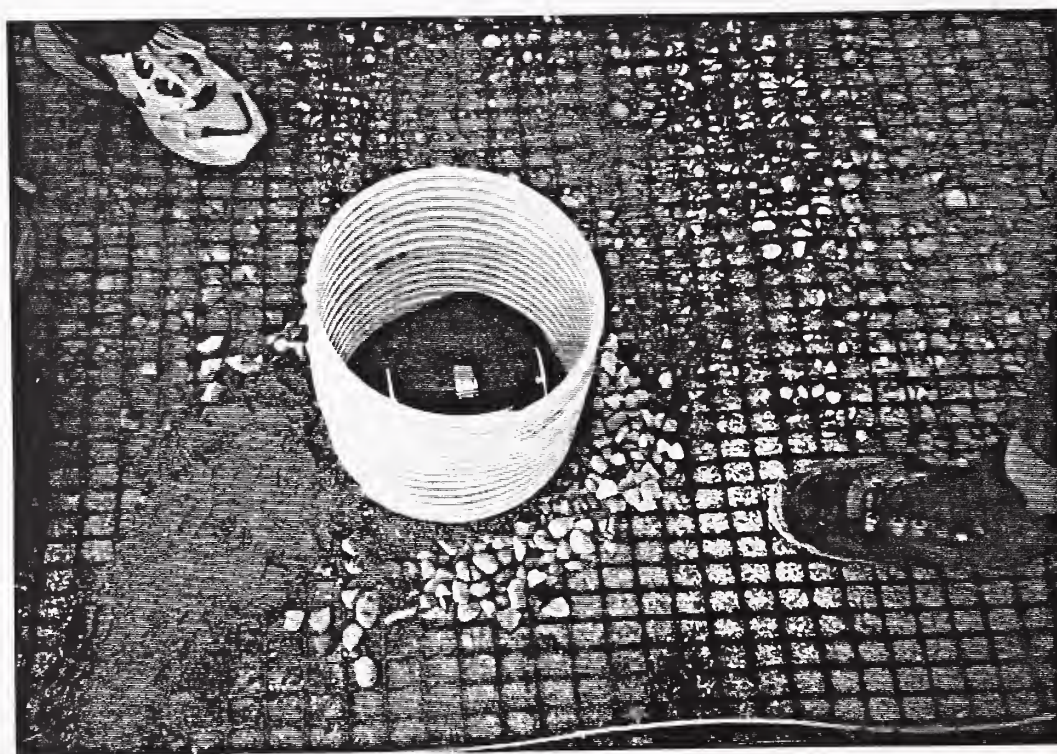
Figure A4.12: Temporary Protection Container for VW Embedment Strain Gage
